# PROGRESSIVE ROOF COLLAPSE DUE TO CLR SHIFTING

BY DAVID R. BOHNHOFF, PHD, PE

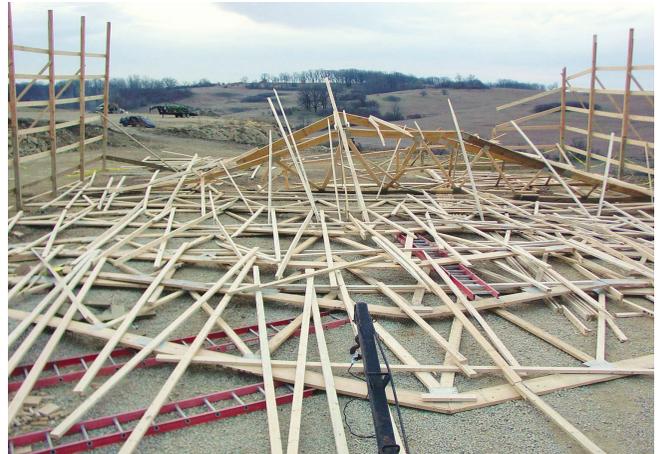
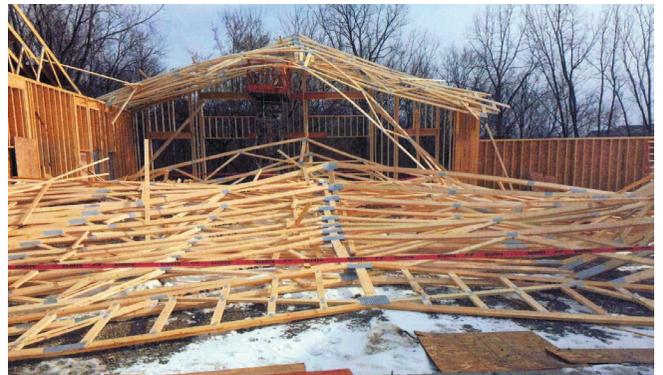
**Figure 9.** Progressive roof collapses during construction are due to the lack of temporary diagonal bracing on top chord CLR. The bottom image is of a conventional stick-frame building with 2-foot on-center trusses.

The diagonal braces shown in Figure 8 are generally temporary—their function being replaced by nailed- or screwed-down roof sheathing. Where this is the case, it is important that the diagonal braces *not* be removed until a portion of the nailed- or screwed-down sheathing has been installed. This is especially true for larger buildings because the probability of failure without truss chord or rafter CLR bracing increases exponentially with an increase in the distance the trusses must clearspan, or span without immediate support (Bohnhoff, 2003). Practitioners who transition from residential to post-frame building construction are often not aware of this and thus ignore the need for diagonal bracing in the plane of the roof during construction. This results in job sites like those shown in **Figure 9**.

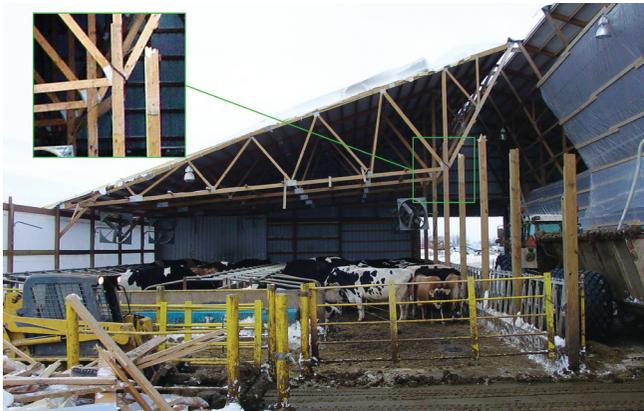
**Figure 10** contains images of a progressive roof collapse that occurred when the CLR on a series of post-to-truss connections

was allowed to shift. This particular collapse occurred in two stages, with the second collapse injuring workers who were trying to remove animals after the first collapse. To prevent further bays from collapsing, a chain and come-along were used to pull remaining post-to-truss connections back to their original positions.

**Figure 10.** This progressive roof collapse was due to shifting of post-to-truss connection CLR. The chain in the lower image, which is also visible in the inset image, was used to pull the remaining post-to-truss connections back to their original positions.

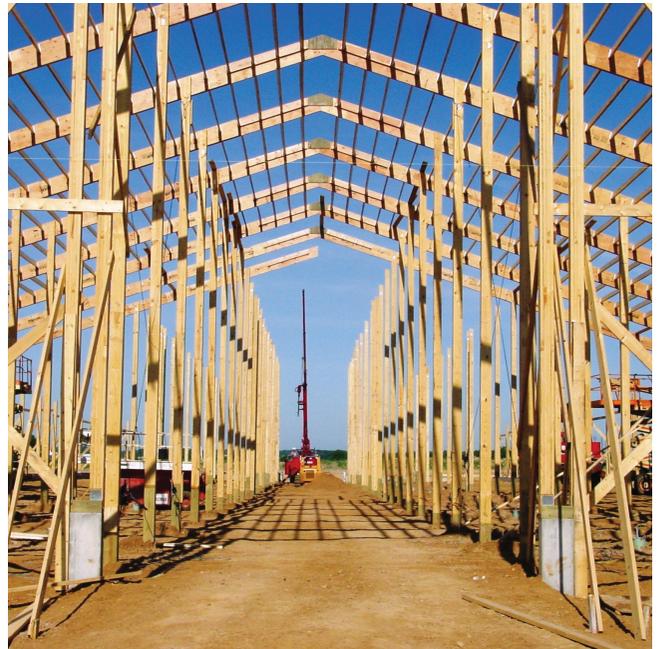
As illustrated in Figure 3, the amount of axial compressive load that can be applied to a member is increased by reducing the slenderness ratio  $L_e/d$ . By adding T-, L-, U-, I- or scab reinforcement along a web member, the designer is effectively turning a long column into an intermediate or short column by increasing  $d$  (as opposed to decreasing  $L_e$  with the addition of CLR). This same approach is commonly used to eliminate the need for CLR on interior posts. That is, interior post dimensions are made large enough (see **Figure 12**) so that the need for continuous lateral restraint is eliminated.

**Figure 12.** The lengthy interior posts being installed in this photo were five-ply glulam assemblies that did not require CLR to withstand design loads.

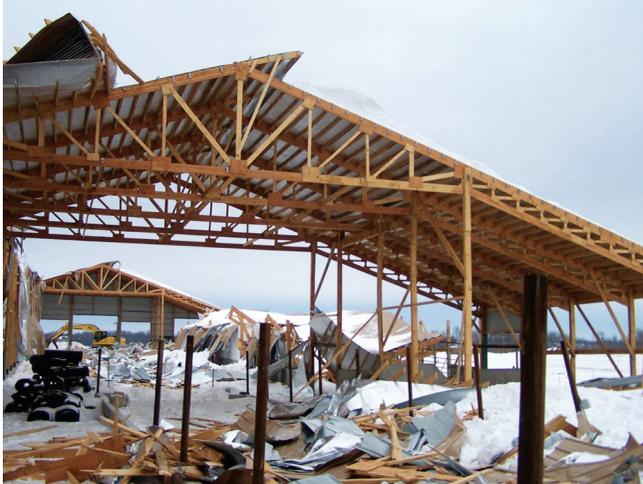
**Figure 13** contains photos of a non-engineered building with roof sections that collapsed when several interior posts buckled. The interior posts were substantially undersized, given that they were supported by only a single row of CLR. The lower

image in Figure 13 shows the significant curvature of one of the interior posts that did not fail. The point of contraflexure in this post is at the single CLR attachment point. In this particular case, the CLR was kept from shifting with a pair of diagonal braces.

**Figure 13.** A building with roof sections that would probably not have collapsed if the interior posts had been increased in size and/or supported with additional rows of CLR
