DO YOU OWN A KILLER BUILDING?

Fatal design flaws can be found in many nonengineered buildings. Check with your structural engineer before proceeding with your next project.

by David Bohnhoff

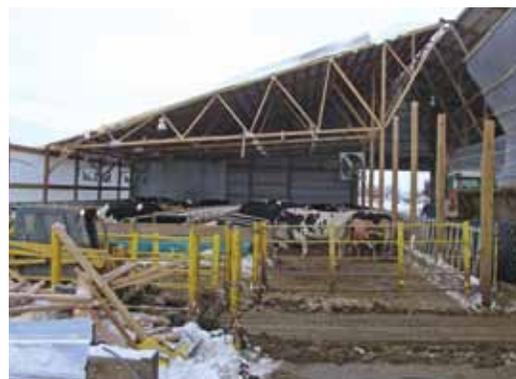
BUILDINGS LACKING ENGINEERING may appear to be an upfront cost savings. But a roof collapse will cost much more.
